**2004 Operations, Maintenance
and Monitoring Report**

**North Lake Mechant Landbridge
Restoration**

State Project Number TE-44
Priority Project List 9

May 2007
Terrebonne Parish

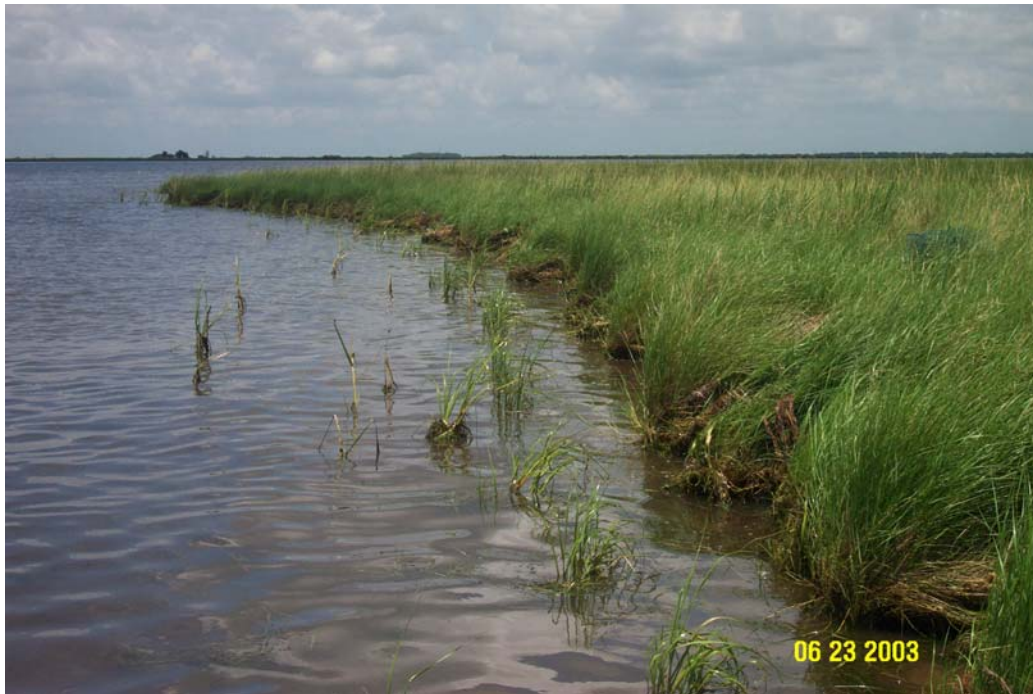
Figure 6. Planted rows of *Spartina alterniflora* along the eastern shore of Lake Pagie.

It is recommended that supplemental planting be done in the future since the initial planting experienced only 65% survival immediately following planting. The project design calls for supplemental planting after CU2 construction is completed to replace vegetation damaged by dredge material placement on the interior marsh. This should also be considered as regular maintenance when periods of high mortality reduce the planted vegetation. In our opinion, the significant mortality was due to unusually high water immediately after planting and poor soil conditions. High water occurs frequently after tropical storm events and during summer when southerly winds push water levels two feet and higher above normal tides. Plants tolerant to being submerged for long periods of times should be considered. It was also observed that the *Spartina alterniflora* (smooth cordgrass) did considerably better in the more compact soils along the shoreline of Lake Mechant. The soils of Lake Pagie have a much higher organic composition and are much more unconsolidated.

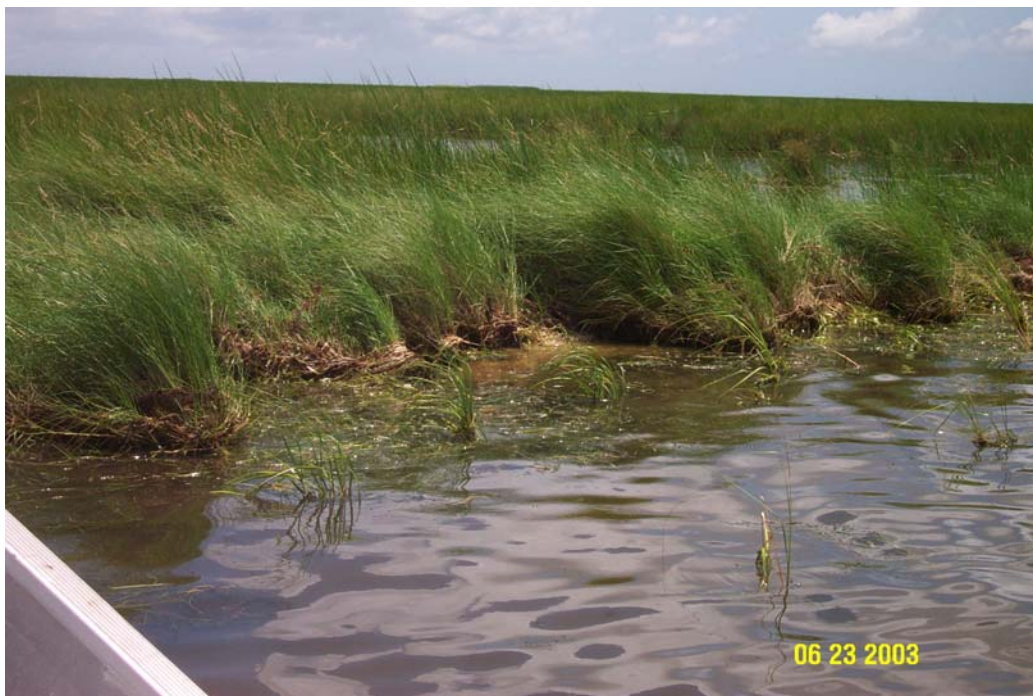
Figure 7. Marsh edge showing drop off and planted vegetation along Lake Pagie.
